Study of the Inner Structure of a Damaged Control Rod by Neutron and X-Ray Radiography and Discrete Tomography

Abstract. A control rod K5 of the 10 MW Budapest Research Reactor was damaged in 2004. We have applied both neutron and X-ray radiography to study the distribution of the residual material in the damaged K5. X-ray radiography visualized the main distribution of the residual materials, like different kinds of B₄C and water, and the frozen gas bubbles, while neutron radiography displayed the fine structure of the congealed B₄C. The 3D reconstruction of the most interesting parts of K5 has been done by discrete tomography.

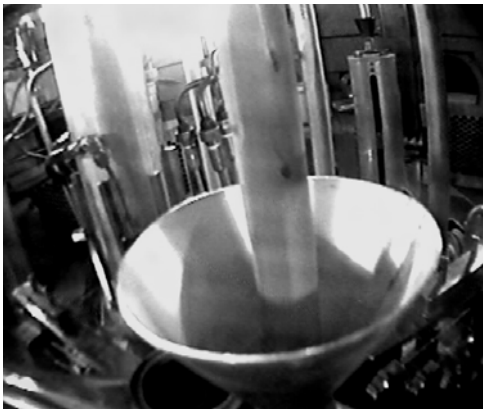
The main parameters of the investigated damaged K5 rod are the following: outside diameter is 27 mm, wall thickness 1.5 mm and length 725 mm. It is made from Al-alloy. It was originally filled up by high solidity B₄C applied as absorber material. In consequence of the damage of the control rod, a certain part of the B₄C came out from the aluminium tube. Figure 1 shows the damaged K5 rod after the cleaning procedure. Two damaged areas (cracks) are visible on the right side of the rod. The smaller crack is shown in Figure 2.

FIGURE 1. Photo of the damaged K5 control rod. **FIGURE 2.** Photo of the crack on the surface of the damaged K5 control rod

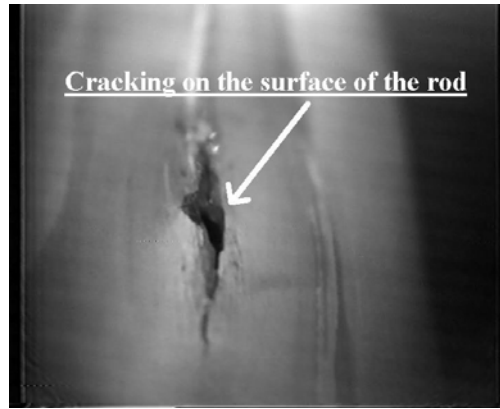
We suppose that the origin of both cracks is the hidden faults of the Al-raw material. Similar type of crack have never been experienced during the operation of the reactor, previously.

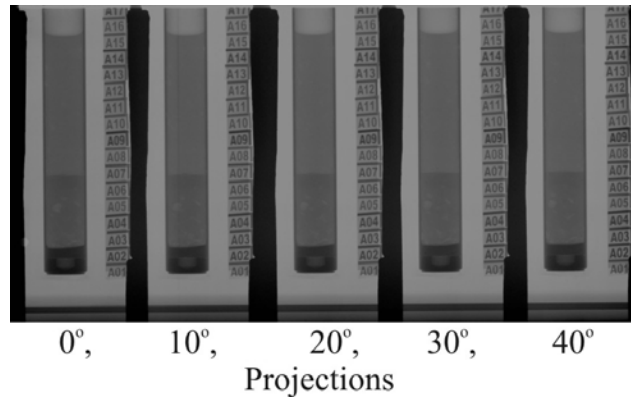
FIGURE 5. X-ray radiography images of the bottom part of the damaged K5 control rod exposed on the same BAS MS Imaging Plate in five projections.

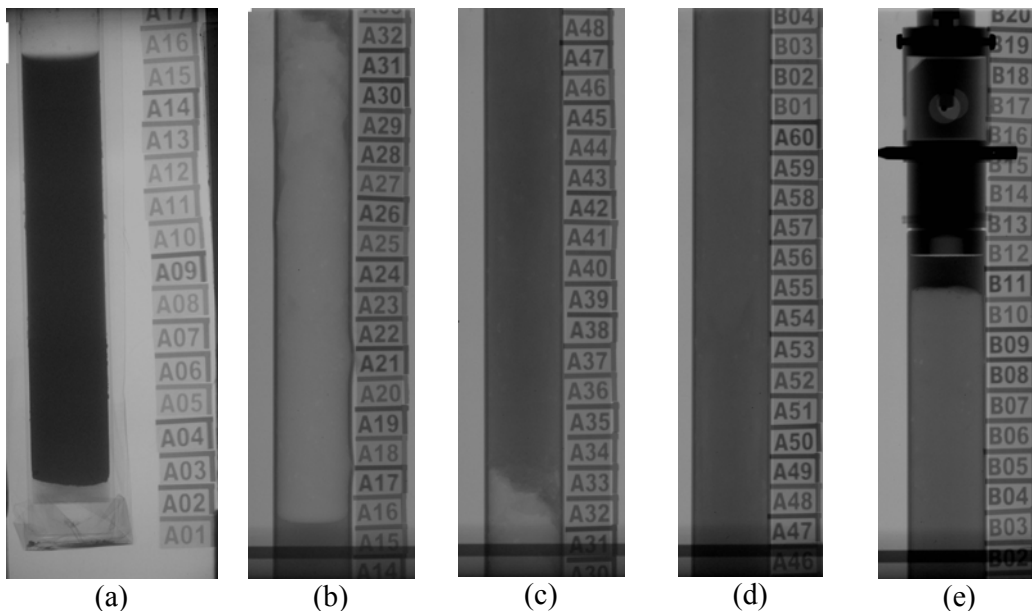
XR images measured along the damaged control rod are illustrated in Figure 6. Figure 6(a) shows the bottom layer (markers A01-A02) with the Al-closing element, the second layer (markers A02-A07) contain the low-solidity B_4C with frozen gas bubbles, while the next layer (markers A07-A16) contain the residual water from the cooling water of the reactor. Figure 6(b) shows the damaged part of the rod, the practically empty Al-tube layer (markers A16-A31). The upper part of the rod (Figures 6(c)-(e)) is intact containing the high solidity B_4C (from A34 up to the top). The inside surface of the empty tube was covered by a thin film of B_4C , but this is hardly visible for XR, however, where the thickness of the B_4C was greater - for example between A28 and A32 – are the trace of the whirlpool is visible.

FIGURE 6. X-ray radiography images of the damaged K5 control rod: (a) bottom part denoted as segment I (scale numbers A01-A16) (b) segment II (A14-A32) (c) segment III (A31-A48) (d) segment IV (A46-B04) (e) upper part denoted as segment V (B02-B20).

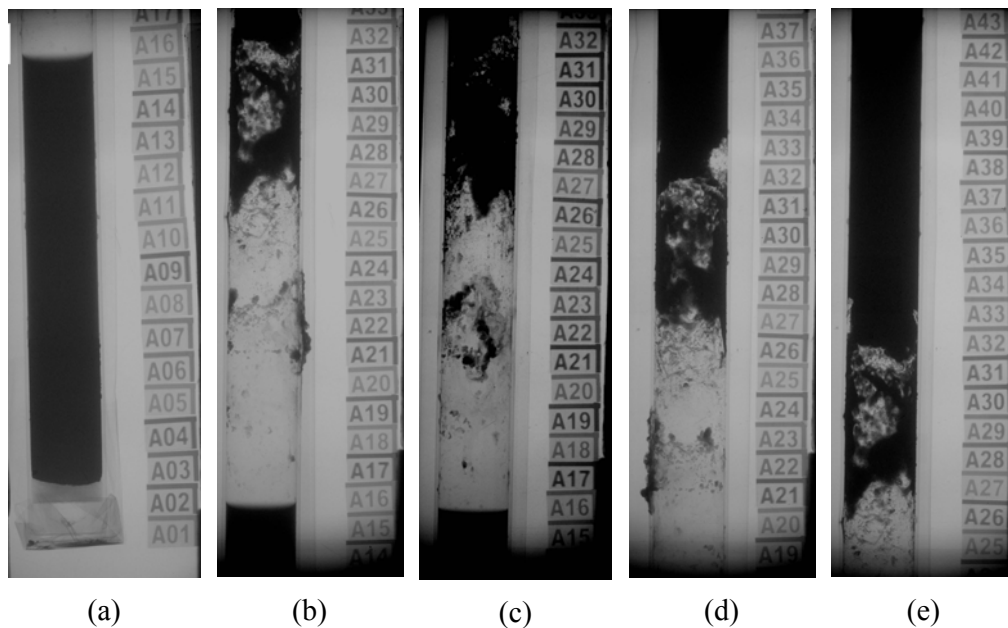
Figure 6 shows the bottom and the destroyed part of the damaged control rod. The low solidity B_4C and water is seen at the bottom of K5 in Figure 6(a). The damaged parts are illustrated in Figures 7(b)-(e). A hole has been formed in the Al-tube (at around scale number A21) surrounded by B_4C . Inhomogeneous distribution of B_4C may be observed, including gaps and smaller holes between markers A27-A33. The upper half part of K5 is intact (above scale marker A34) containing high-solidity B_4C . No further details are observable in the NR images, due to the high absorption of boron.

FIGURE 6. Neutron radiography images of the damaged K5 control rod (exposure time 10 sec): (a) bottom part denoted as segment I (scale numbers A01-A16); (b)-(c) segment II (A14-A32) in different projections; (d) segment II-III (A20-A37); (e) segment II-III (A25-A43).

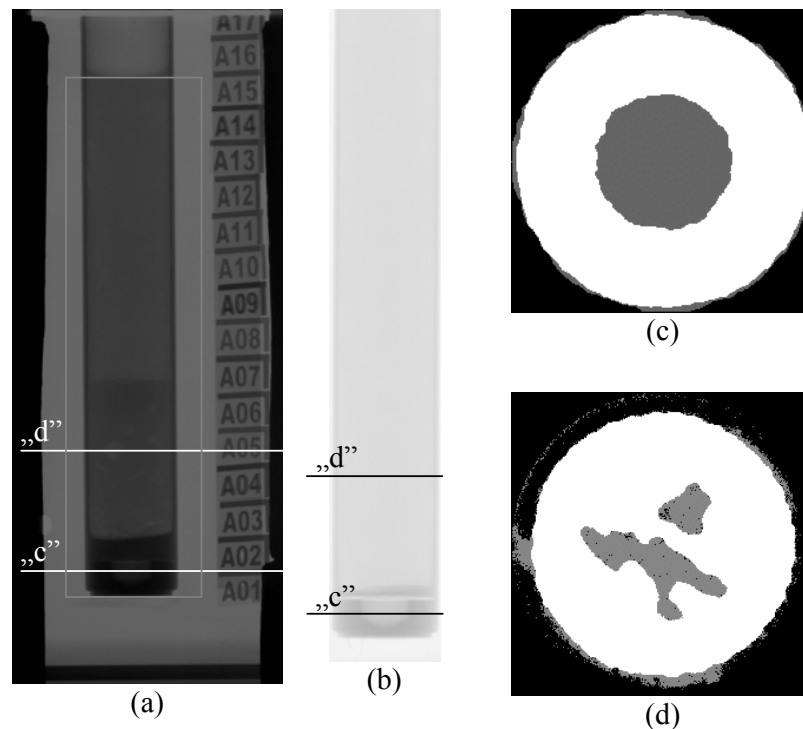
FIGURE 8. (a) One of the original acquired projections of the control rod. (b) The (a) projection after the application of pre-processing steps. The grey rectangle surrounds the cropped area for DT (c) Reconstructed cross-section denoted by “c” in (a) and (b). (d) Reconstructed cross-section denoted by “d” in (a) and (b).

After the execution of pre-processing steps the projections became ready for reconstruction. One of the corrected projections can be seen in Figure 8(b). The projection images had the size of 228 x 1352. Since the method can reconstruct only slice-by-slice, the reconstruction of 1352 slices took slightly more than 18 hours on a machine of average speed (Intel P4, 3.0 GHz, 512 MB RAM). The 3 dimensional visualization of the resultant cross-section images (see (c)-(d)) was performed by the 3D Slicer [6] image processing software package, which permits one to build up a volume rendered spatial model as seen in Figure 9. It can be observed that in the upper part of the control rod the method gave a very good result, but in lower parts it is messed up, which may be due to the irregular distribution of the absorber material.

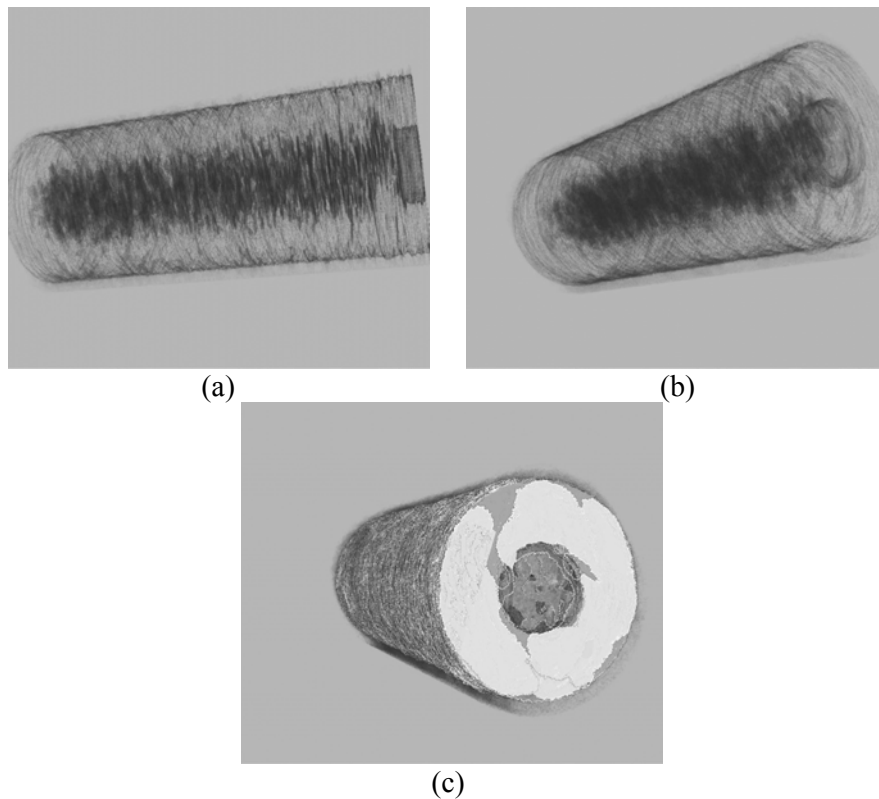
X-ray and neutron radiography have given attractive complementary information on the inner structure of the damaged K5 control rod. The double phase material distribution was shown by XR in the bottom of K5, while the fine details of inhomogeneous distribution of the residual B₄C on the wall of K5 were observed by NR. We can conclude that as a consequence of the damage, 144 cm³ high of density B₄C was missing from the K5 control rod, 22.5 cm³ low density B₄C, 40.5 cm³ water and 76.5 cm³ air were found instead of the original material. A 3D picture was

FIGURE 9. (a)-(b) Volume rendered 3 dimensional visualizations of K5 control rod with transparent wall. (c) Volume rendered 3 dimensional visualization of the K5 control rod with non-transparent wall.
